**A GUIDE BOOK ON  
GEOLOGICAL SECTION OF BHUPI SHERCHAN MARG  
(POKHARA-BENI HIGHWAY), WESTERN NEPAL**

**A GUIDE BOOK ON  
GEOLOGICAL SECTION OF BHUPI SHERCHAN MARG  
(POKHARA – BENI HIGHWAY), WESTERN NEPAL**

**U.B. Pradhananga  
Senior Divisional Geologist  
and  
S. Dhakal, Geologist**

**Government of Nepal  
Ministry of Industry, Commerce and Supplies  
Department of Mines and Geology  
Lainchaur, Kathmandu, Nepal  
July, 2008**

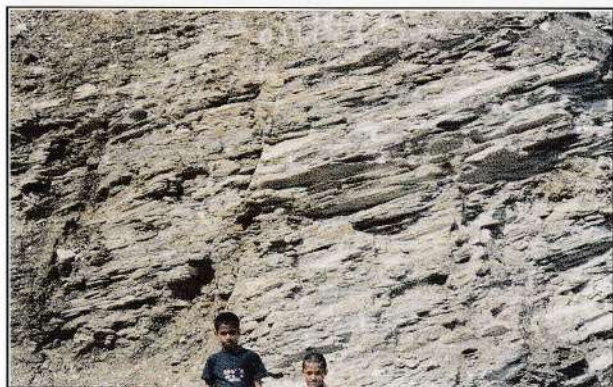
Thinly banded (1cm to 4cm thick), fine grained bluish grey to greenish grey (silicious to argillaceous) phyllites of Kunchha Formation are exposed in the area. The rocks are exposed as the area has been excavated to prepare the site for the construction of a new house (photo-1). The attitude of the bed is  $N30^{\circ}W$  and dip  $20^{\circ}$  SW. A local fault plane exposed in the area has trend of  $N65^{\circ}W$  and dip  $65^{\circ}$  toward south.

Photo 1: Fine grained greenish grey phyllite of Kunchha Formation exposed in the excavated area (Feb.2007)

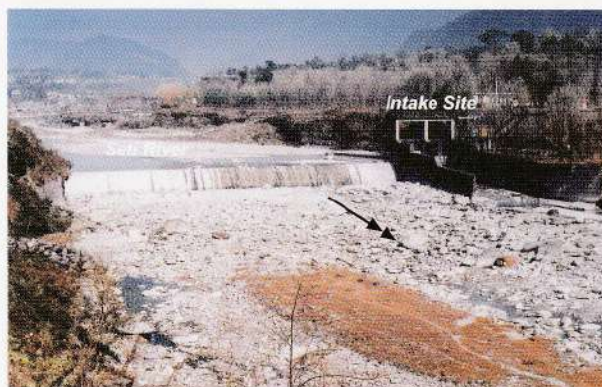
At about 5km from Pokhara, shows the intake site of the Seti canal (photo 2). The intake for the canal is located on left bank of the Seti River. The canal fulfills the cleaning water demand of the local people in the northern part of the Pokhara Valley. In south eastern part; the water is used for irrigation of the wide agricultural land of Pokhara Valley.

Photo 2: Seti dam and intake of Seti canal on left bank of Seti River.

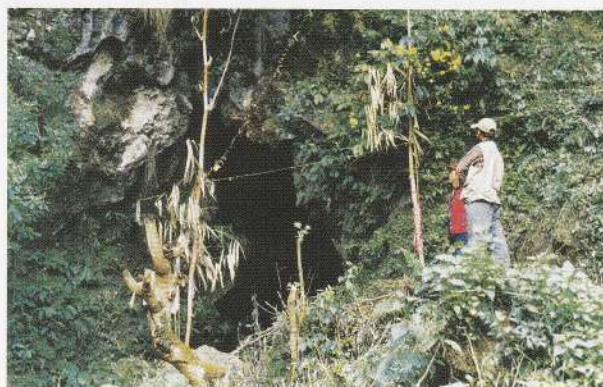
A small cave is present on the left side of the road at a distance of 40km from Pokhara (photo-5). The cave exposed on a small stream and is situated about 50m uphill from the road. The cave seems to be formed by breaking and leaching of calcareous glacio-fluvial deposit. Numerous boulders of 15 to 20m diameter are present on the kholsa by the side of the cave.

Calcite leaching is common inside the cave. The mouth of the cave has the shape of triangle. It is 3m wide at base and 3m high at the centre.

Photo 5: A cave in glacio-fluvial deposit at Dada.

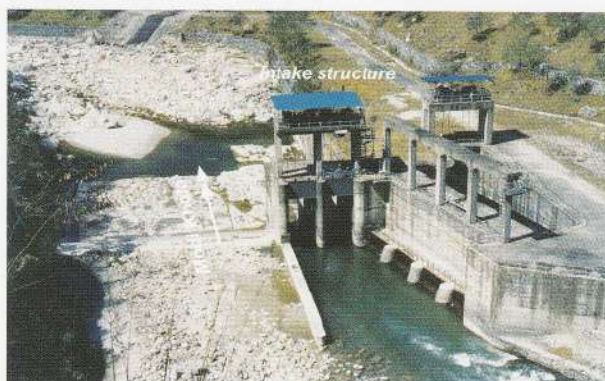
The intake site of the Modi Khola Hydro Power Plant is located on the right bank of khola. From the intake site, about 500m long tunnel brings the water to settlement reservoir located also on the right bank of the khola. The reservoir is about 300m long. The water from the reservoir is carried through the tunnel to the power house located at Dimuwa.

Photo 6: Water of the Modi Khola diverted to the tunnel on right side of the river in Intake site of Modi Khola power house

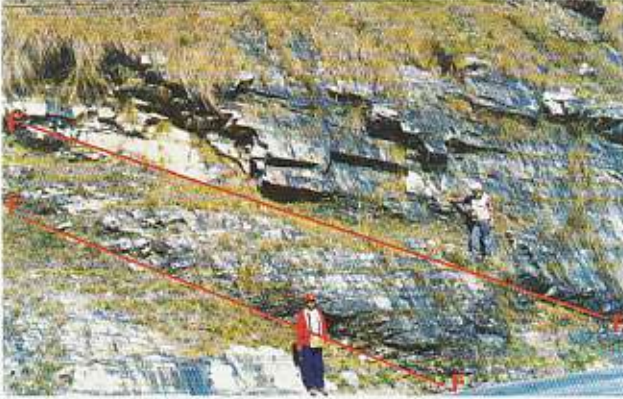
Thick bedded to massive, very fine to fine grained, white grey to greenish grey quartzite of Kushma

Quartzite is exposed in this area. The quartzite has dominance of quartz grains with few flakes of sericites. Poorly developed ripple marks are present. A wedge shaped medium bedded and fractured quartzite band of about 5m wide has pushed into the quartzite as a result of local faults. Upper contact of the wedge has sharp contact but the lower contact has brecciated rock fragments and about half meter thick soil has been developed in the contact area.

Photo 7: Medium bedded and fractured quartzite band in thick bedded quartzite of Kushma Quartzite.

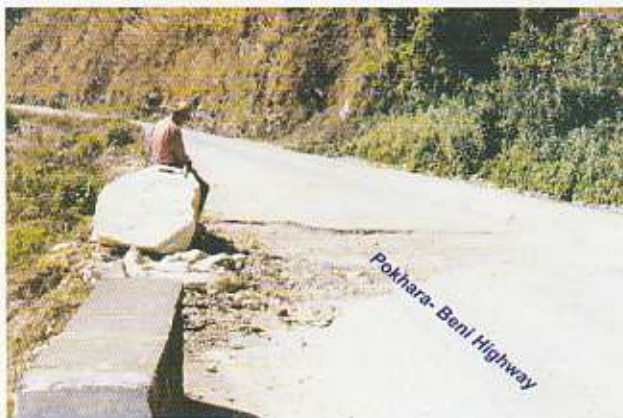
White quartzites of the Kushma Quartzite are highly fractured and jointed causing easy disintegration of the rock exposures. As a result rock falls and consequent road damages are quite common in this Biruwa-Maldhunga sector of the Pokhara- Beni Road passing through the quartzite area. A white quartzite block of about 1.25m diameter has fallen from the hill slope on right side of the road. The rock fall has damaged 1.5m wide part of the road for a distance of about 4m (photo-8). The quartzite has ripple marks.

Photo 8: Fall of the ripple marked quartzite, which has damaged the road.

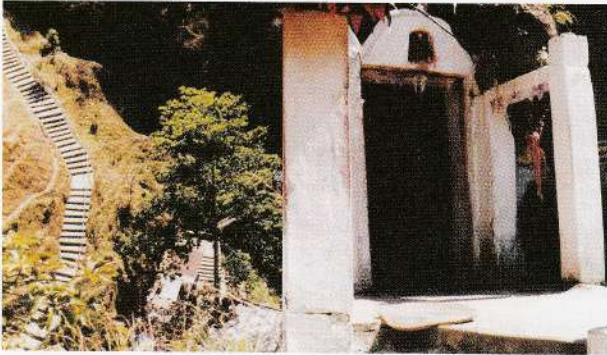
A cave is present 50m below the road level near the confluence of two streamlets at Kushma. There are lot of stalactites and stalagmites inside the cave. The cave is about 1km long and sloping up inside. About half meter wide RCC pavement is provided up to a distance of 700m inside the cave. In this area a small temple of Lord Shiva is present and electric light is provided up to this area. Beyond the distance of 700m, the cave gets steeper and narrower. A beautiful gate is made at the entrance of the cave. The cave can be approached from two sides, one from the northern part of the Kushma Bazar and another from the road near the district police station at Kushma. The cave is

developed in glacio-fluvial deposit.

Photo 10: Steps and Entrance leading to Gupteshwar Cave.

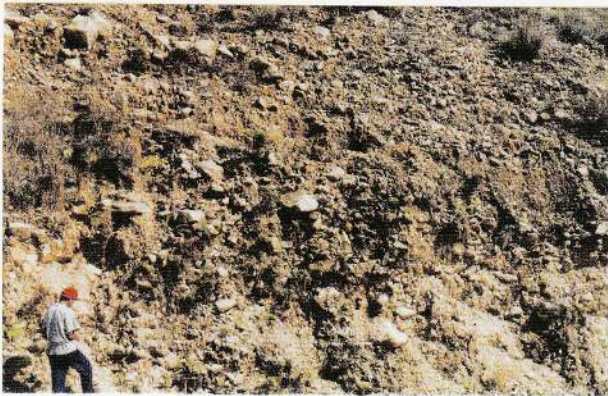
Scree Deposit of gravels, pebbles and boulders of white grey, fine grained quartzite and some phyllites of Kushma Quartzite occur on the right side hill slope, NW of Kushma. The scree in the form of slope debris consists of pebbles about 25%, cobbles about 30%, boulders about 25% and sand / silt about 20%. As the fragments are not cemented, rock fall to the road is quite common in this area and needs frequent maintenance work.

Photo 11: Colluvial deposits of quartzite.

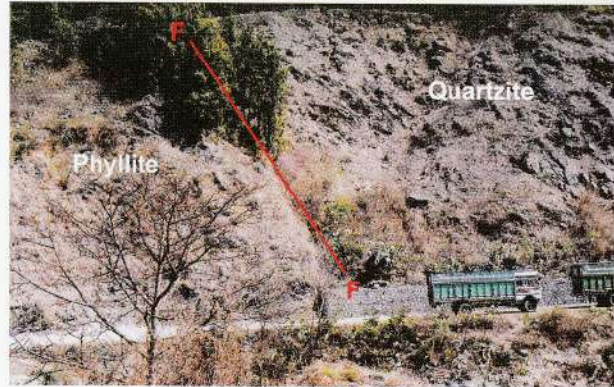
A fault plane with fault scarp of about 20meter long is present about 1 km north-east of Armadi on right side

of the road. Vegetation including trees is grown on fault zone between the underlying green phyllite and overlying quartzite. Green to dark green phyllite with 10-30 cm thick green sandstone bands is in faulted contact with thick bedded white quartzite. The fault plane has trend of N65°E and dip 50° toward S. The fault zone is 1.5 to 2m wide and consists of breccias of green sandstone and phyllite. Thick vegetation including trees has grown along the fault zone (photo-12).

Photo 12: Vegetation including trees grown along the fault contact between Phyllite and Quartzite at Armadi.

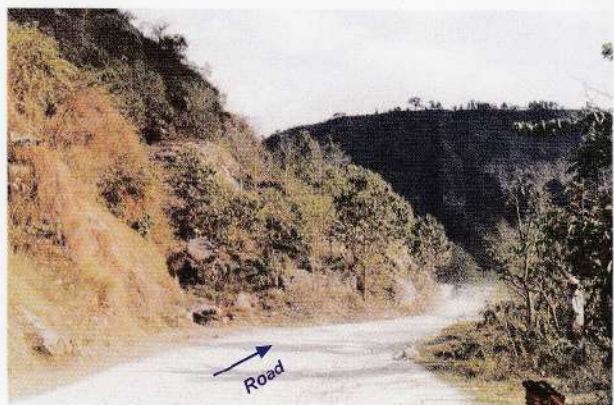
About 50m long creeping landslide from the hill slope on right side of the road near Bayerbot has damaged the road. The landslide has covered the existing road and a temporary road was built about 15m away (SW-W) from its original position. The landslide has occurred in glacio- fluvial deposit of Kaligandaki River.

Photo 13: Landslide debris occupying the road at Bayerbot.

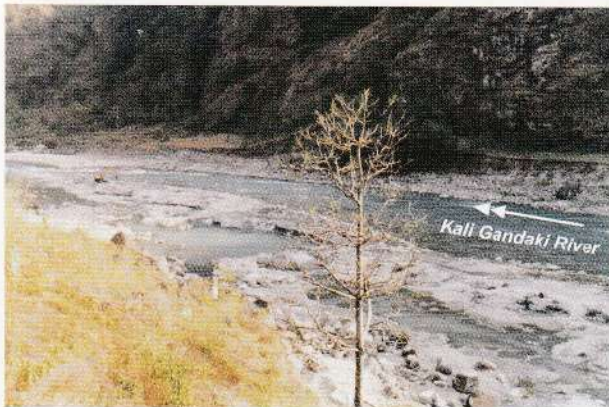
Sand along with gravels is quarried on flood plain of Kali Gandaki River on its left bank. The sand is quarried to fulfill the demand of sand in the new construction activities going on in Beni Bazar and Baglung Bazar. As the sand has been quarried quite below the water level of nearby Kaligandaki River, the water from the river is seeping into the quarried area creating a temporary pond. If uncontrolled quarrying of sand in the flood plain continued, the river may change its flow course and may damage the road on its left bank.

Photo 14: Creation of badland topography by haphazard extraction of sand on the flood plain.

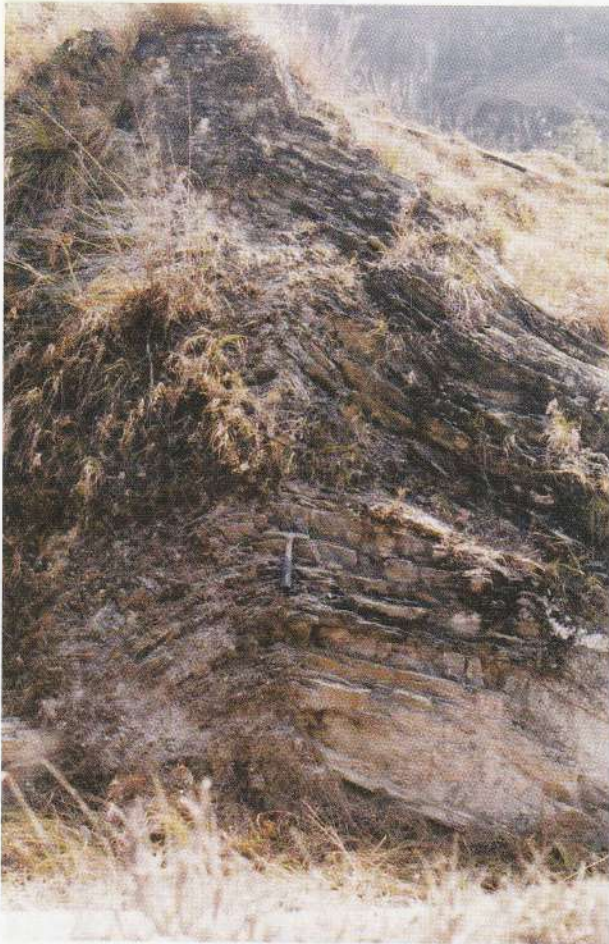
10 to 40 cm thick, light grey to white grey, fine grained quartzite interbedded with very fine grained light greenish grey sericitic, chloritic phyllite of Kunchha Formation are forming an anticlinal fold structure. Further to the right limb of the anticlinal fold, a complimentary synclinal fold occurs. The axis of the syncline is faulted forming a reverse fault (photo-16).

Photo 16: Folding in thinly bedded quartzite and phyllite, exposed in left bank of Kaligandaki River.

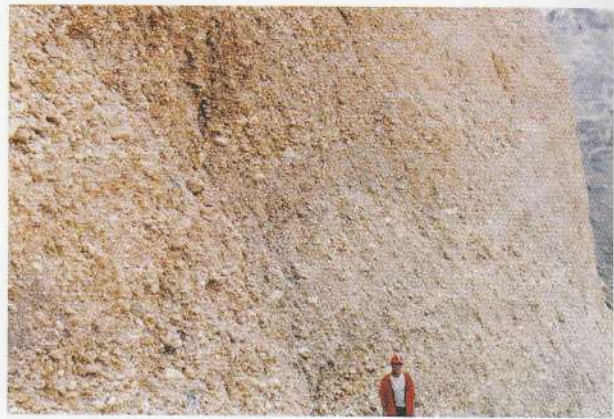
A thick exposure of glacio-fluvial deposit is present on right bank of the Kaligandaki River. The exposure is more than 80m thick and is exposed on east scarp of the Baglung terrace deposit. The deposit consists of sand and silt with gravels 30%, pebbles 50%, and cobbles and boulders 20%. The gravels, pebbles are moderately sorted and consist of white grey, greenish grey quartzite, fine grained biotite schist, gneiss, calc-gneiss, marbles, phyllites, limestone, calc-schist and some dark grey slate. Generally the cementing material is calcareous. The gravel, pebbles are 80% sub-angular to sub-rounded and about 10% are angular to sub-angular. Top of the fluvial deposit is 230m above the river bed. Red lateritic soil has been developed on top of the fluvial deposit. The exposure lies on the hill

slope, one kilometer west of the road.

Photo 17: Gravels, pebbles and boulders of glacio-fluvial deposit on right bank of Kaligandaki River.

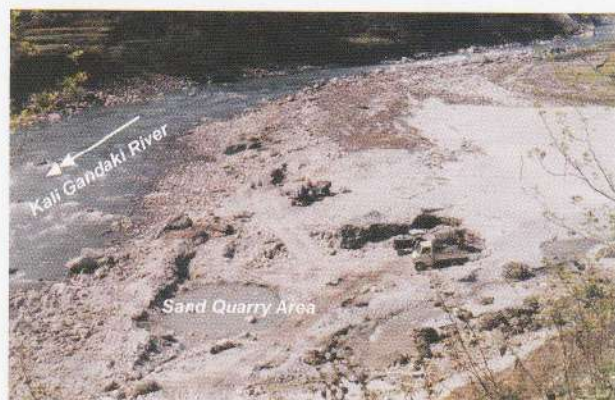
Sand is quarried on the left bank of Kaligandaki River about 1km south of Lasti. The quarrying has taken place 2-3m below the surface. At places, river water has entered into the excavated area. The sand deposit in the area is about 200m long and up to 100m wide. Upper part of the sand deposit is fine grained sand with silt but the lower part consists fine to medium grained sand. The sand mining has caused the formation of artificial low land in the flood plain of Kaligandaki River.

Photo 18: Artificial ponds on flood plain of Kaligandaki River created by extraction of sands below the water level of the river.

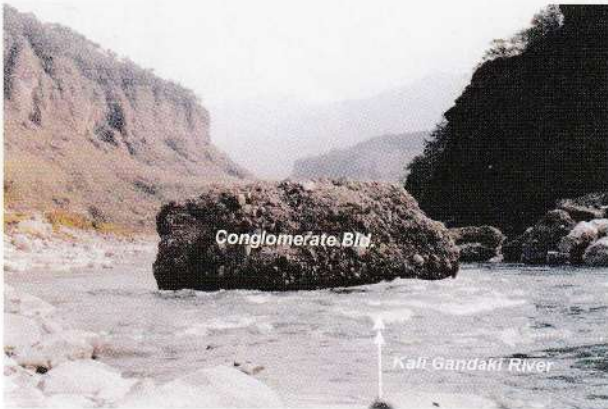
Very huge conglomerate boulder derived from the glacio-fluvial deposit is lying on the middle of the Kaligandaki river channel causing water to divert on both sides of the boulder. The boulder is about 15m long and 5m high above the water surface and occupies about 50% of the river channel in that location. The boulder is consisted of pebbles, cobbles to boulder. Pebbles and cobbles are sub-rounded to rounded, while big boulder and rock fragments are sub-angular to sub rounded. The conglomerate has calcareous cementing material with matrix of coarse sand. This boulder seems to have rolled down from the side hill consisting of glacio-fluvial deposit.

*Photo 19: Compact and tough conglomerate boulder of glacio-fluvial deposit, bifurcating the water of Kaligandaki River.*

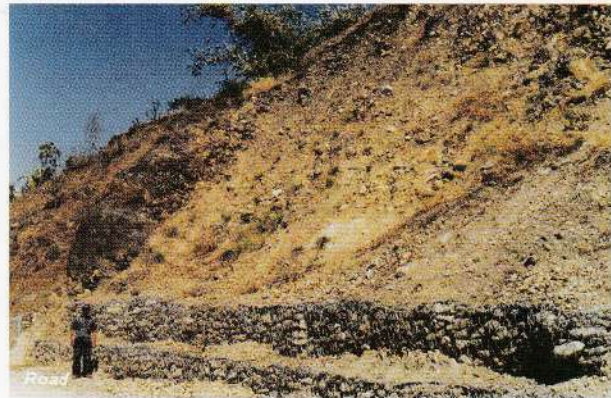
Landslide in glacio-fluvial deposit consisting of sub-rounded to rounded gravels, cobbles and boulders with some angular rock fragments is present in the area. Rocks are quartzite, gneiss and phyllites. Presence of some big boulders is retarding the sliding process at some places. Stepped gabion protection wall is provided at the toe of the slide to protect the road from the slide.

*Photo 21: Landslide affecting the road south of Beni.*

**Spot No. 21, (78.00km): Slide on glacio-fluvial deposit, south of Beni, (Left side of the road).**

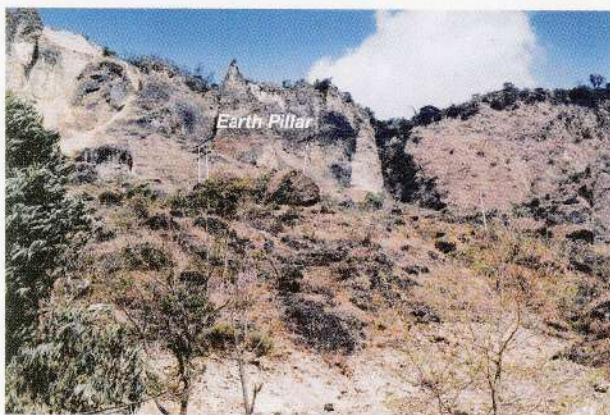
Big blocks of glacio-fluvial deposits are toppling down the slope. The blocks range in size from a meter to 10 meter in diameter. The deposit is exposed up to 240m high from the current river bed, which indicates that the deposit is more than 240 m thick. A deep vertical erosion of the deposit has created a pointed pinnacle/ earth pillar of about 30m high (photo-22). In these fluvial deposits, small streams are found to erode downward vertically creating deep and narrow gorges. Another important feature of the fluvial deposit in the area is that the ensuing erosion has created topography with steep scarp on the upper part, relatively gentle slope in the middle part and deposition of toppled blocks on the toe part.

*Photo 22: Badland topography created by erosion of glacio-fluvial deposit, south of Pari Beni.*

**Spot No.22, (79.00km): Erosion Feature in glacio-fluvial deposit, south of Beni, (Right side of the road).**

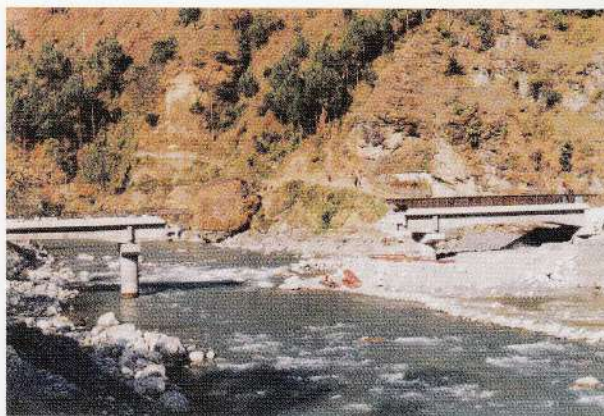
*Photo 23A: Bridge over Kaligandaki River under construction.*

Bridge over Kaligandaki River at Beni was under construction in February 2007 (Photo-23A). Right and left side parts of the bridge had been completed and only central part needed to be constructed. Supporting structures needed to construct the middle part, had been readied, as seen in photo in right part of the bridge. The bridge was completed in June 2007(Photo-23B). Now the vehicle coming along the bank of Kaligandaki River can reach Beni. Previously, only the vehicles coming through Baglung Bazar can reach Beni by crossing bridge over Myagdi Khola, a tributary to Kaligandaki River near Beni Bazar.

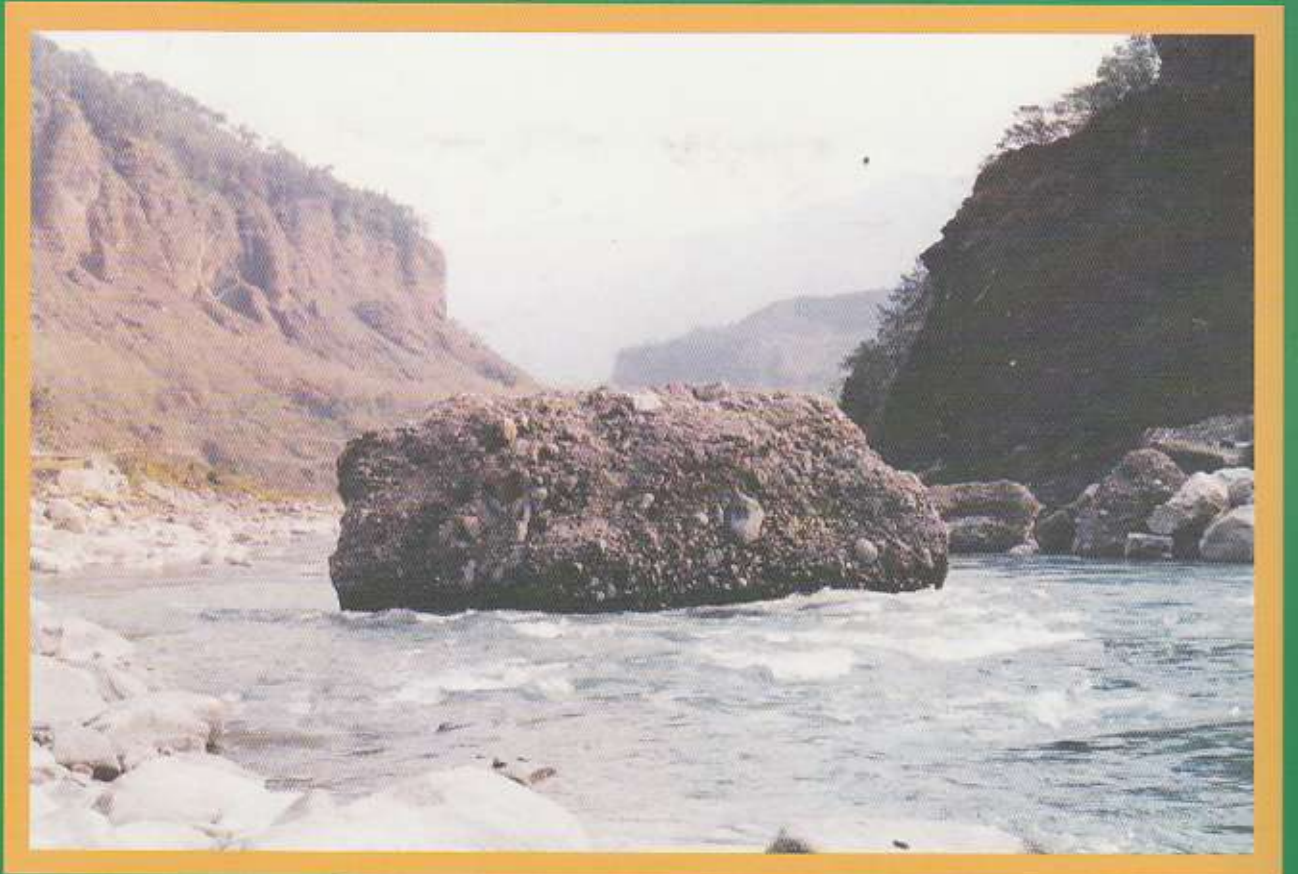
Huge conglomerate boulder in the middle of Kali Gandaki River at Lasti
